**MONTOUR No. 4 REFUSE BANK**

PHASE I INSPECTION REPORT  
NATIONAL DAM INSPECTION PROGRAM

JULY 1981

MONTOUR NO. 4 REFUSE BANK  
WASHINGTON COUNTY, COMMONWEALTH OF PENNSYLVANIA  
NDI NO. PA 00865  
PennDER NO. 63-92

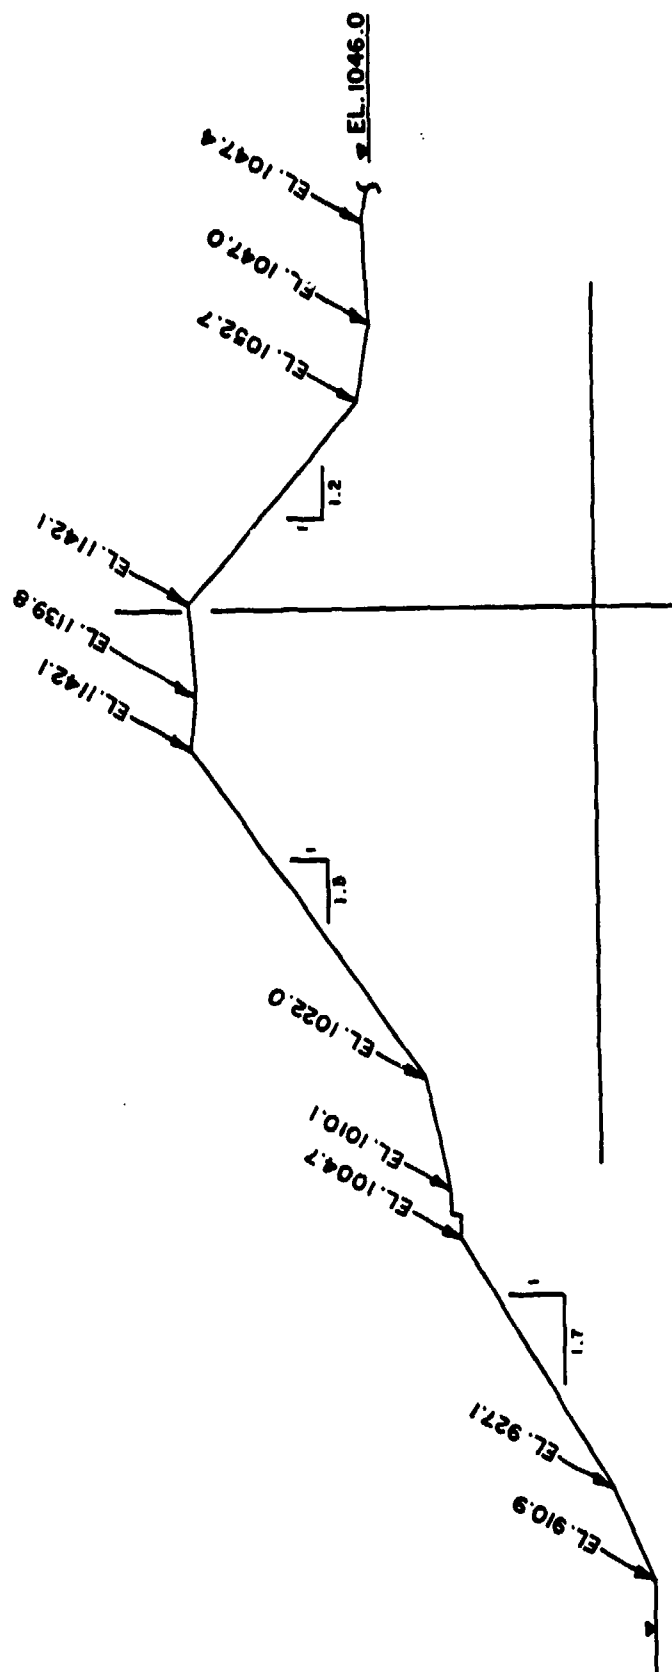
**FIELD SECTION A-A**

Locally, very steep slopes exist on all faces of the embankment, but little or no sloughing or slope instability were observed. The embankment slopes are also quite steep in a general sense as indicated by Field Section A-A. However, there were no signs of major slope stability such as cracks, scarps or anomolous bulges.
